OUR SHORE Coastal Erosion Assessments and Site Reports: Great Diamond Island

Emma Polhemus, Shore Corps Steward, Maine Conservation Corps & Island Institute
May 2026

**OURSHORE Quick Assessment: Barge Landing & Property X
Great Diamond Island, ME**

OURSHORE Quick Assessment: Private Property A
Great Diamond Island, ME

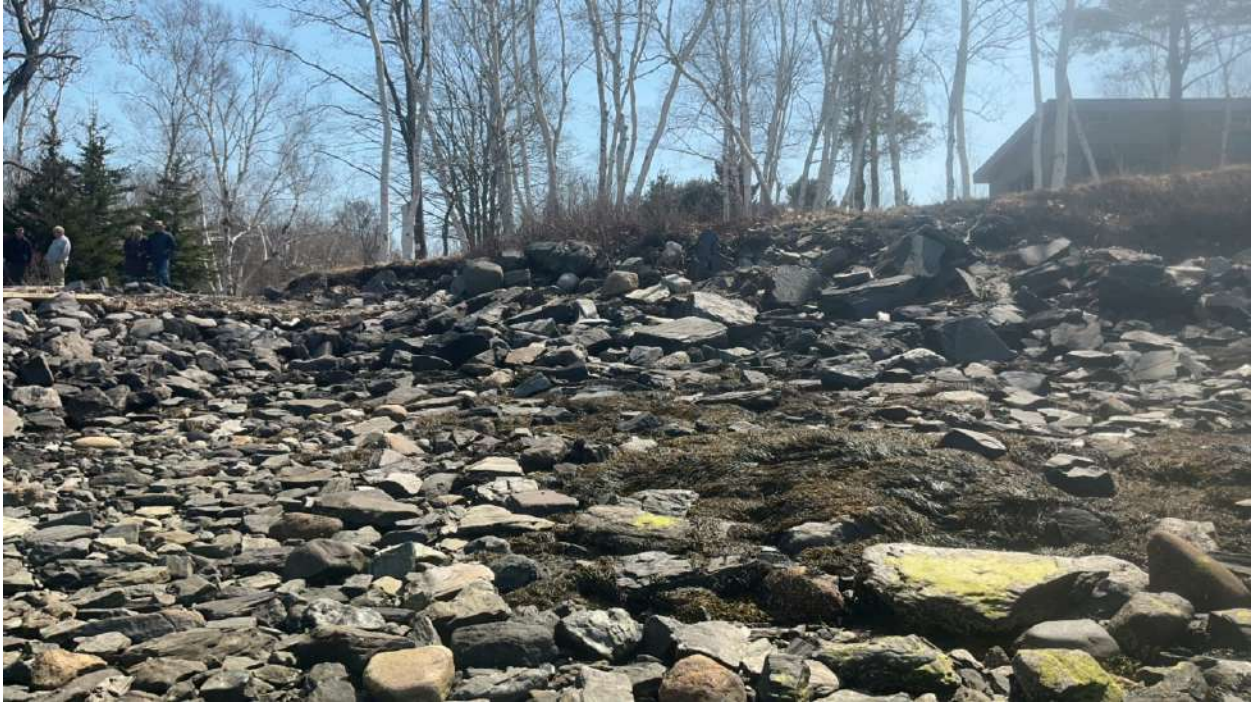
Figure 1: A section of the shoreline including the barge landing to the left.

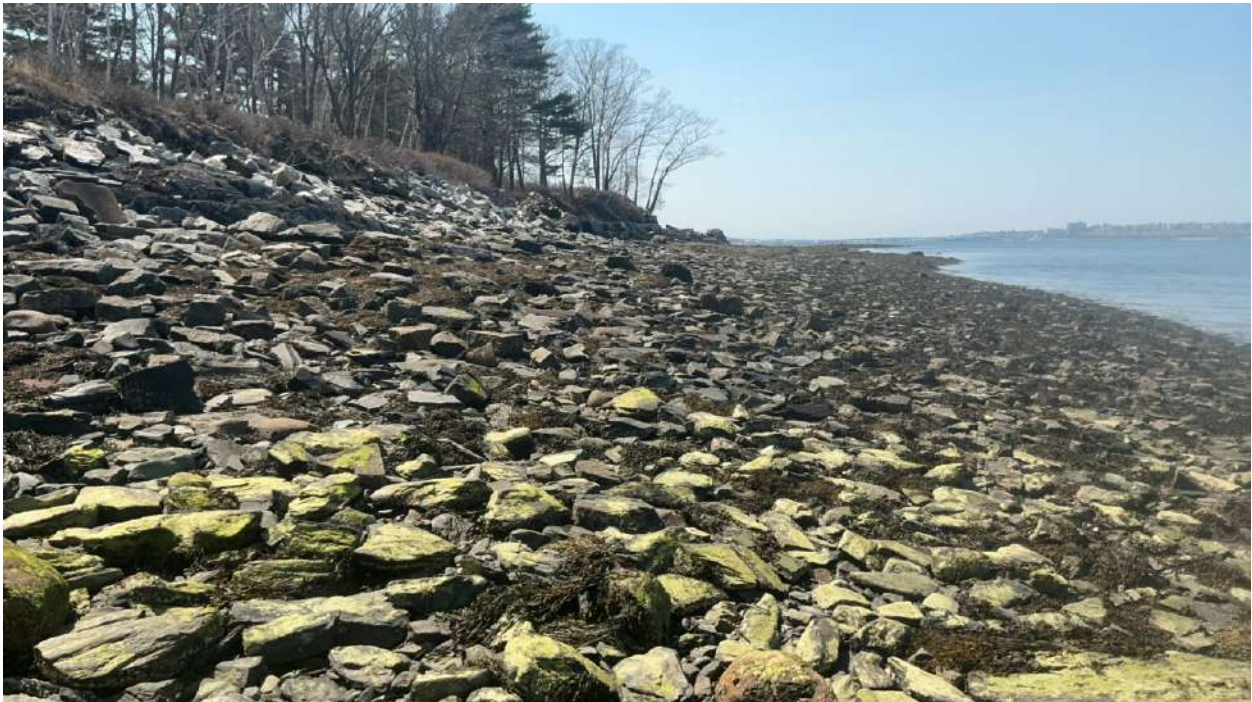
The aging stone stabilization at the site is degraded, and soil erosion is visible above the current extent of the stabilization. The failed drainage system is contributing to worsened erosion where water now drains from the bank.

Figure 2: The shoreline viewed from the edge of the barge landing.

The stone slope protection that was previously placed has degraded and is no longer functioning as intended. Shifting and slumping of the stones has contributed to this degradation. Adding vegetation throughout the riprap on the bank connects the stones to the underlying soil, holding them in place and creating a more durable design that becomes stronger over time as the plants mature. A "rooted" riprap design also improves the quality of the shoreline habitat for wildlife.

Live staking is an effective method of adding vegetation to existing riprap stabilization on a shoreline that does not have a geotextile filter layer. This technique uses branch cuttings of dormant native shrubs from certain quickly-rooting species. These live stakes are able to produce roots and grow into a new plant when pushed into the soil. Live stakes can easily be planted into existing gaps within the riprap stones so they reach the underlying soil, allowing for revegetation without having to disturb or remove the existing riprap.

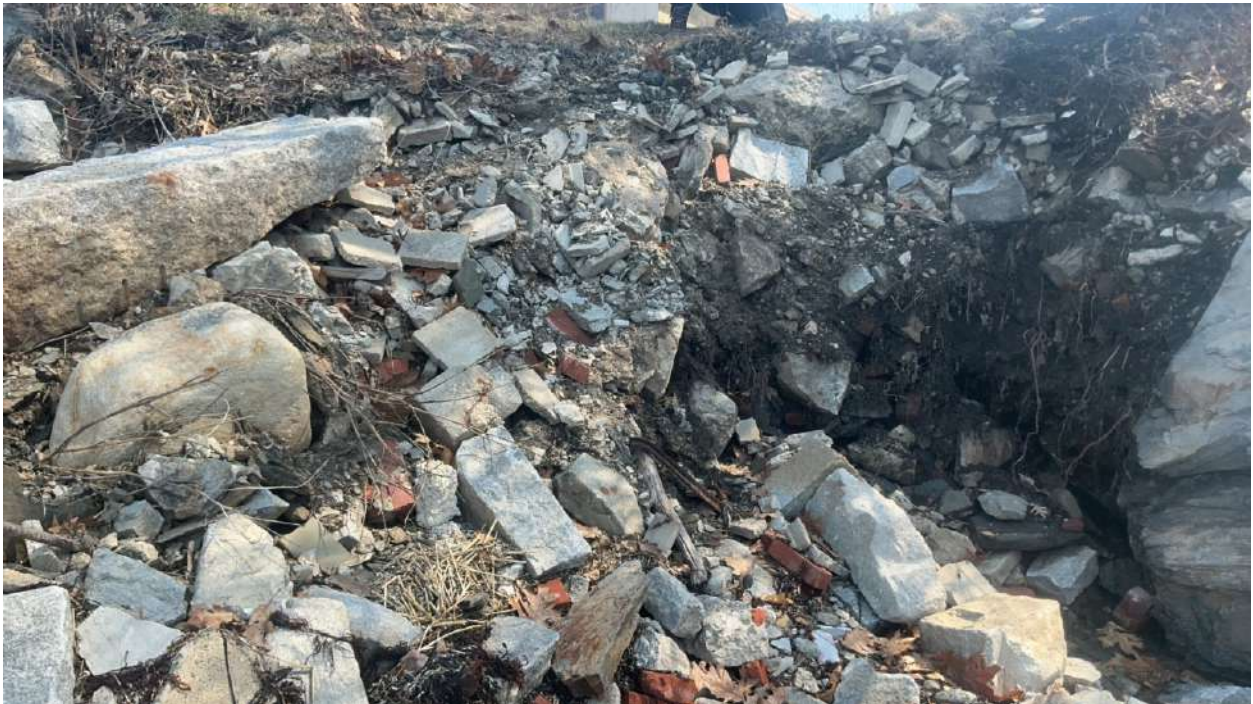
This area of Great Diamond Island was altered by past military land uses. Impacts to the site environment include the presence of stone and construction debris within and in front of the bank. The outfall of a drainage pipe used to exit the bank on the shoreline of Property X but the pipe failed in 2025 and water now drains directly out of the bluff face.

Figure 4: Water now drains from this section of bank after a drainage pipe failed. Bricks and debris are visible in the bank.

An effective and resilient shoreline stabilization design should incorporate elements that minimize the impacts of groundwater and surface water in addition to wave erosion. At this site, a degraded drainage system is eroding soil and creating a saturated, vulnerable section of the bank. Addressing this source of instability will reduce the amount of intervention needed in other areas of the bank.

When stabilizing an area of the bank that drains a high volume of water or concentrated flows, targeted stone stabilization may be necessary. A layer of gravel underneath larger stones will help water drain from the bank while stabilizing the underlying soil. Adding vegetation to the drainage area will create a root network that can filter out soil particles so they do not get washed out through the stone.

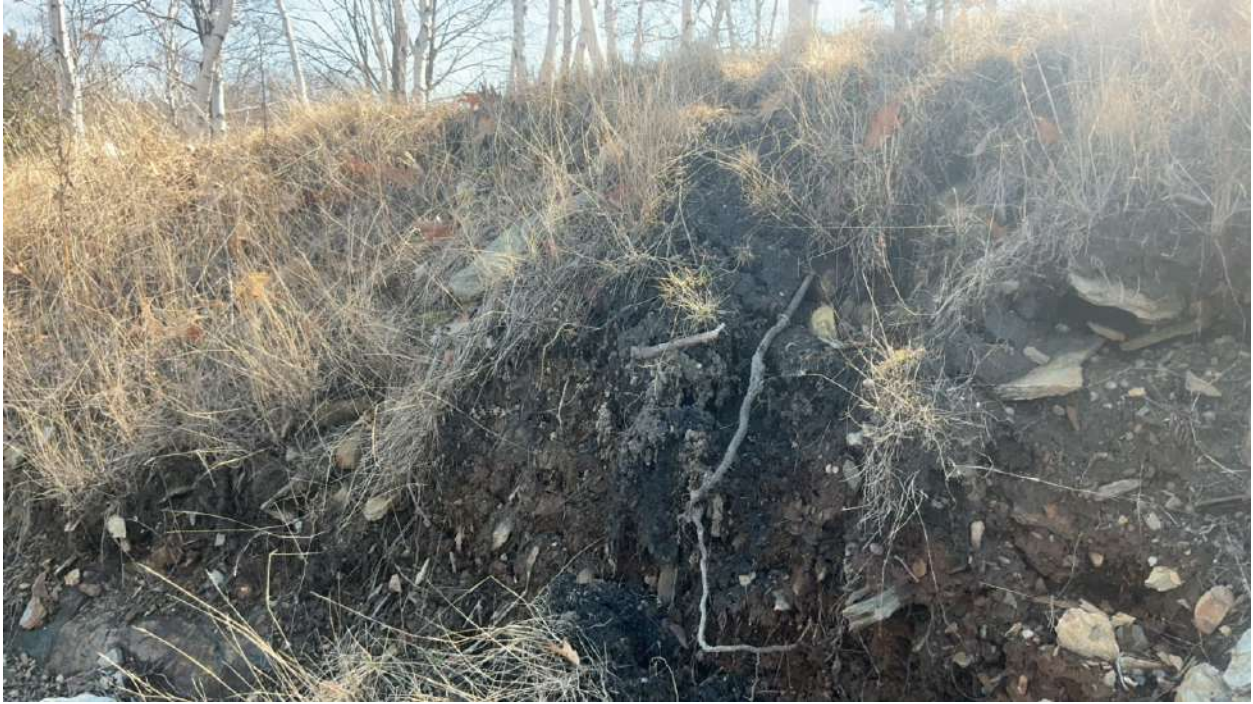
Figure 5: Soil erosion is visible above the top of the placed stone in this section of bank adjacent to the barge landing.

Add vegetation to existing stone stabilization:

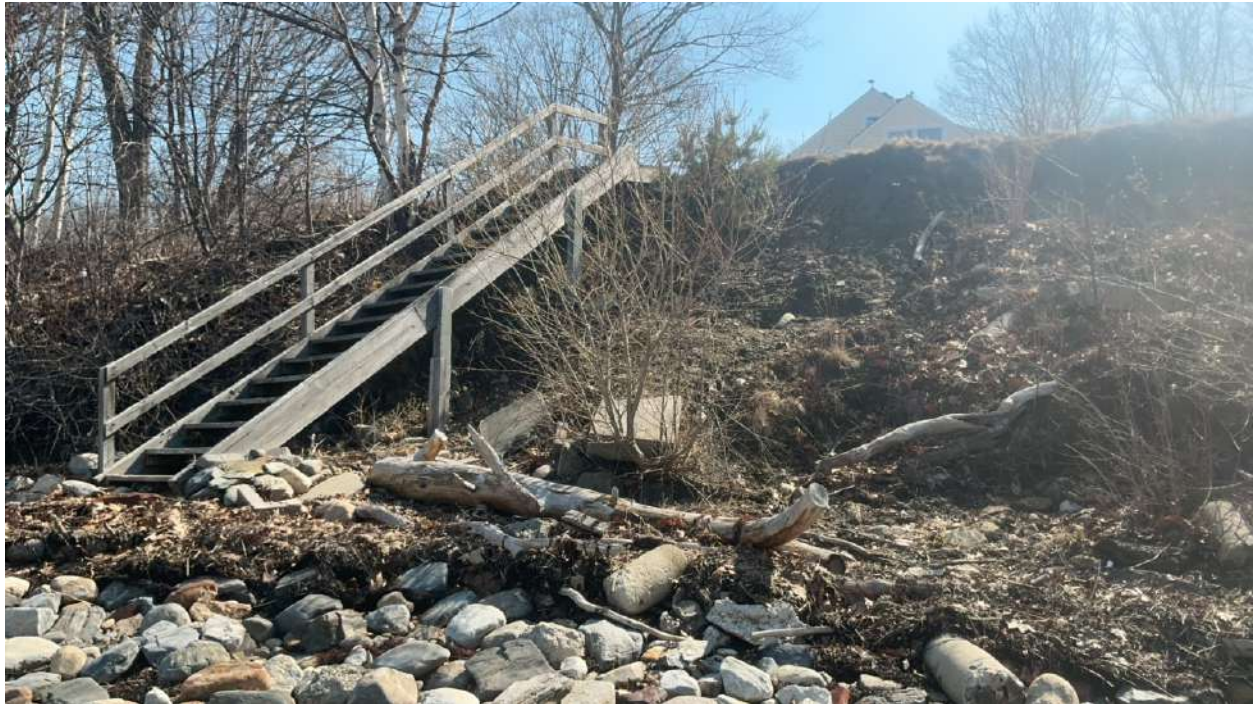
Figure 2: Photograph of a portion of the bluff face at the site near the north end of the property.

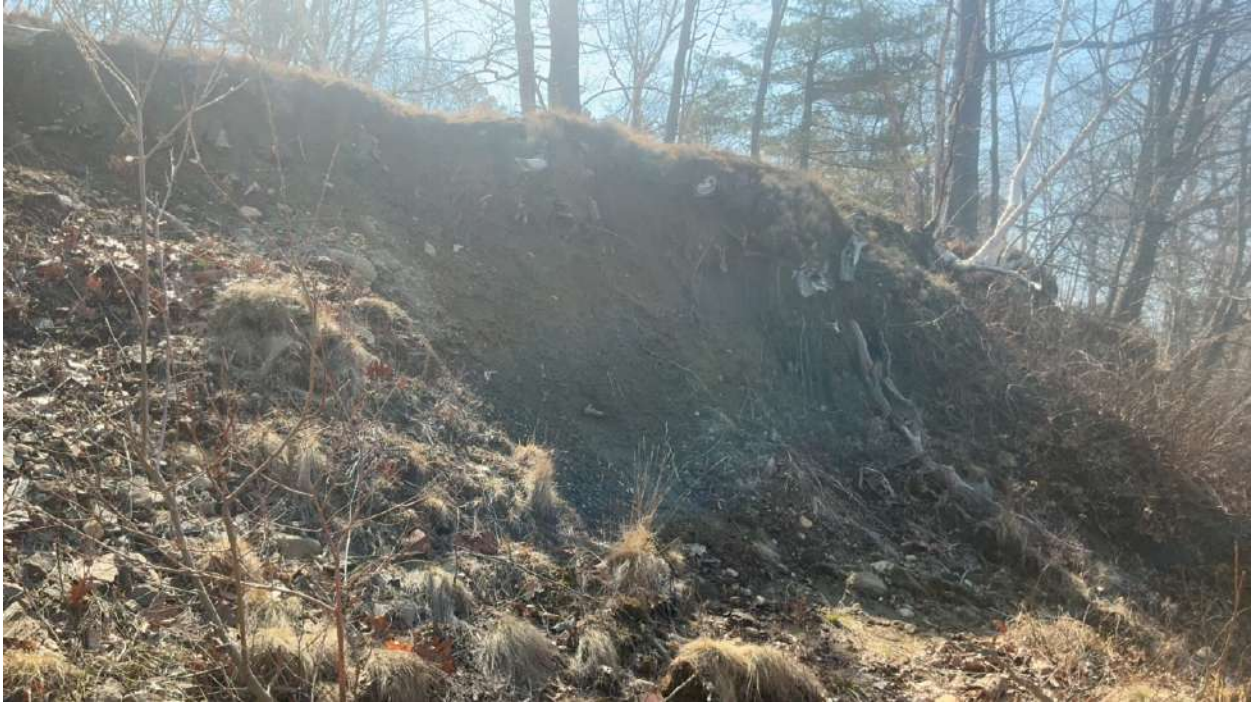
Figure 3: Photograph of a portion of the bluff face at the site near the south end of the property.

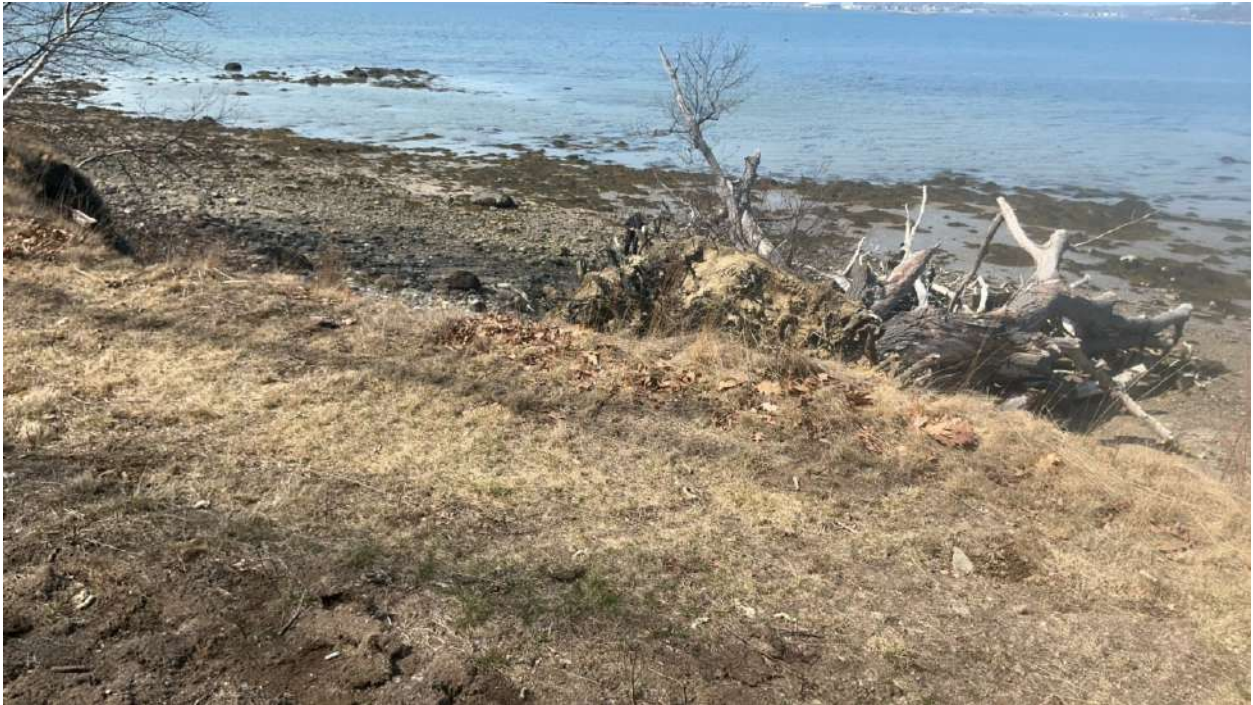
Figure 4: Photograph from the top of the bluff at the site showing the bluff edge and sand and cobble beach.

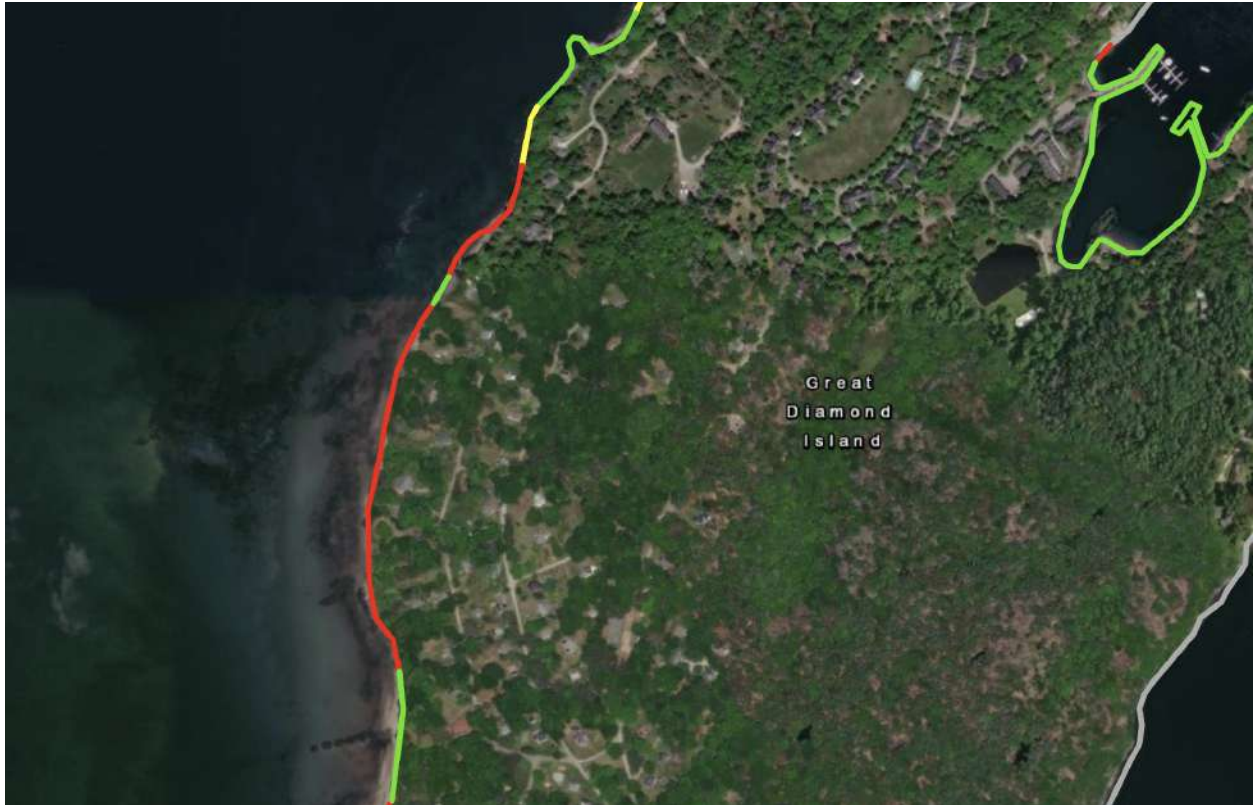
The coastal bluff at the site was designated as Highly Unstable by the Maine Geological Survey in 2020 (Fig. 7). The property owners have noticed indicators of significant bluff erosion at the site. Most notably, a large oak tree growing on the top of the bluff fell in recent years, displacing the soil attached to its root system and causing the upper bluff edge to recede by over 10 feet where the tree stood (Figs. 8-9). Additional signs of bluff instability and erosion include areas of bare soil and exposed roots on the bluff face as well as blocks of sediment at the bluff toe that have slumped from higher on the bluff. Indicators of groundwater saturation, which contributes to bluff instability, were also noted at the site, including visibly dark and saturated sediment in the bluff face as well as a localized, active groundwater seep (Fig. 10). During the site visit, groundwater could be seen draining and running out of the seepage area.

Figure 7: Maine Geological Survey Coastal Bluffs map of the west shore of Great Diamond Island. Red indicates bluffs mapped as Highly Unstable, including the bluff at the assessed site.

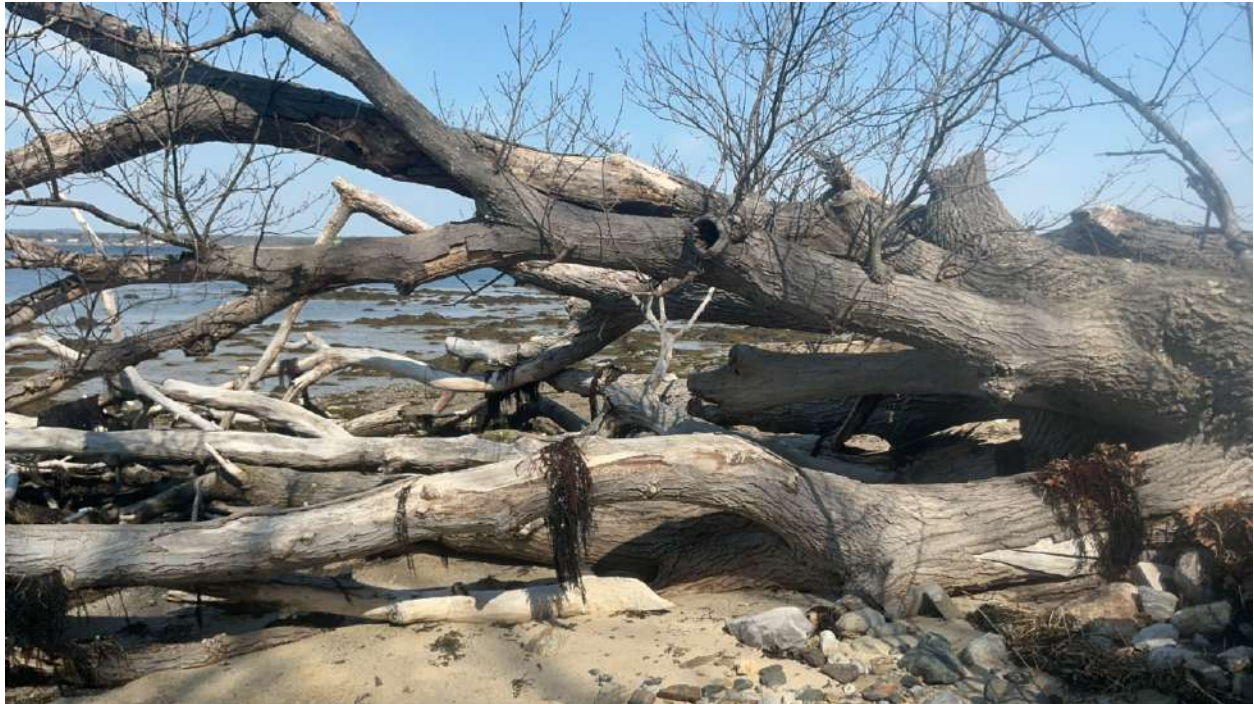
Figure 8: This large oak tree fell from the top of the bluff due to toe erosion and slumping.

The large oak tree that fell from the bank at this site clearly demonstrates how hazard trees can increase bank instability and erosion. When possible, it is best to cut trees that are beginning to lean or fall near the bank to remove weight and reduce the chance of the stump falling. After the tree falls, leaving the trunk and root wad in place, as has been done at this site, is beneficial for shoreline stability. The structure of the branches and roots creates roughness that helps to diffuse energy from oncoming waves.

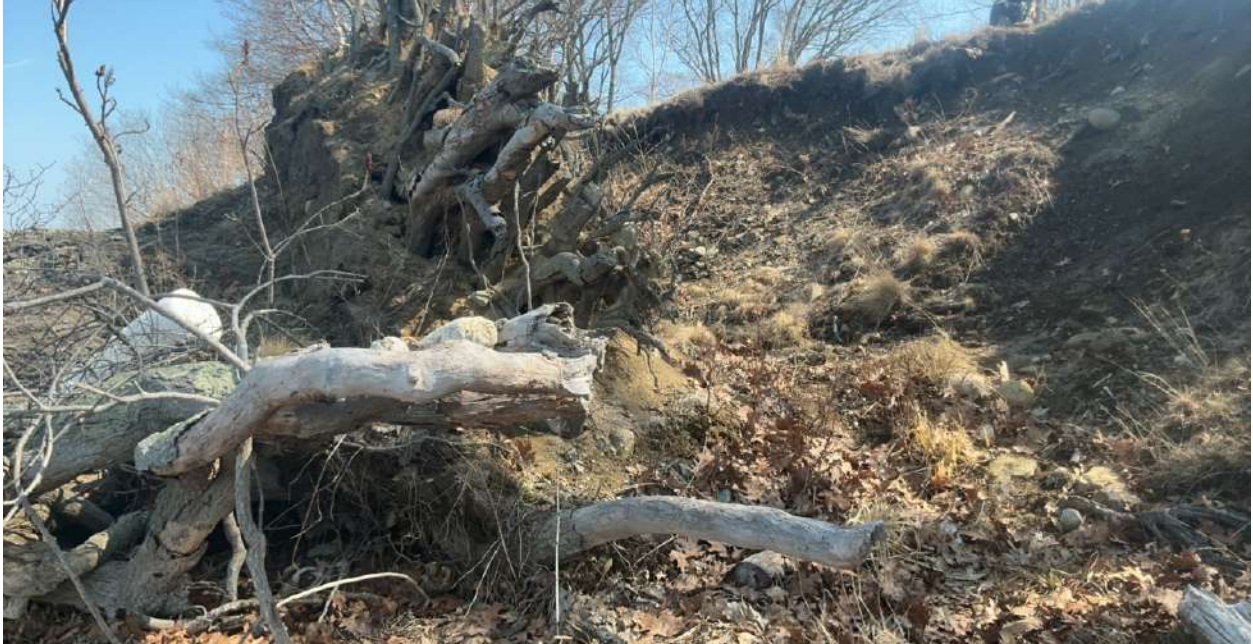
Figure 9: Photograph showing the root wad of the fallen oak tree and the resulting exposed and displaced soil on the bluff face.

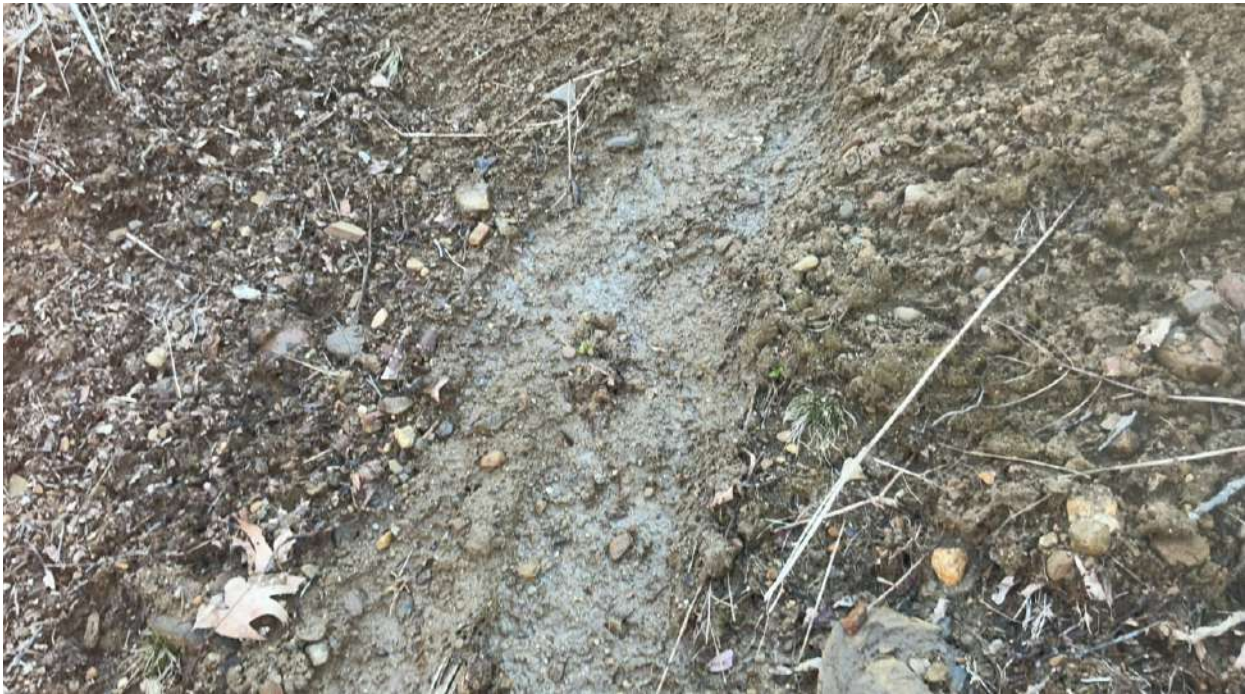
Figure 10: Photograph of the groundwater seep, visible as an area of shimmery, wet soil.

There are indicators that groundwater saturation is significantly impacting slope stability at this site. An oversaturated bank is more vulnerable to erosion from waves and is more likely to slump. Managing groundwater saturation will be an important component of any erosion control plan at the site.

Groundwater saturation may be a result of natural hydrology of the site or caused by land use factors like lawn irrigation or septic systems. The property owners described the approximate location of the property's septic system as directly inland from the position of the groundwater seep on the bluff face, which suggests that contributions from the septic system may be leading to bluff saturation. A septic professional can help identify and manage issues like aging or damaged systems. Following the recommended septic tank pumping schedule is also important to prevent excess groundwater contributions.

Remaining groundwater saturation can be mitigated by installing and maintaining a dense vegetated buffer near the bank. Vegetation draws water into its roots from the bank, and larger, deeper rooted plants remove more water than lawn grass. A minimum buffer width of 10 ft from the edge of the bluff inland is recommended, and further reducing lawn area will continue to increase groundwater uptake and bank stability.

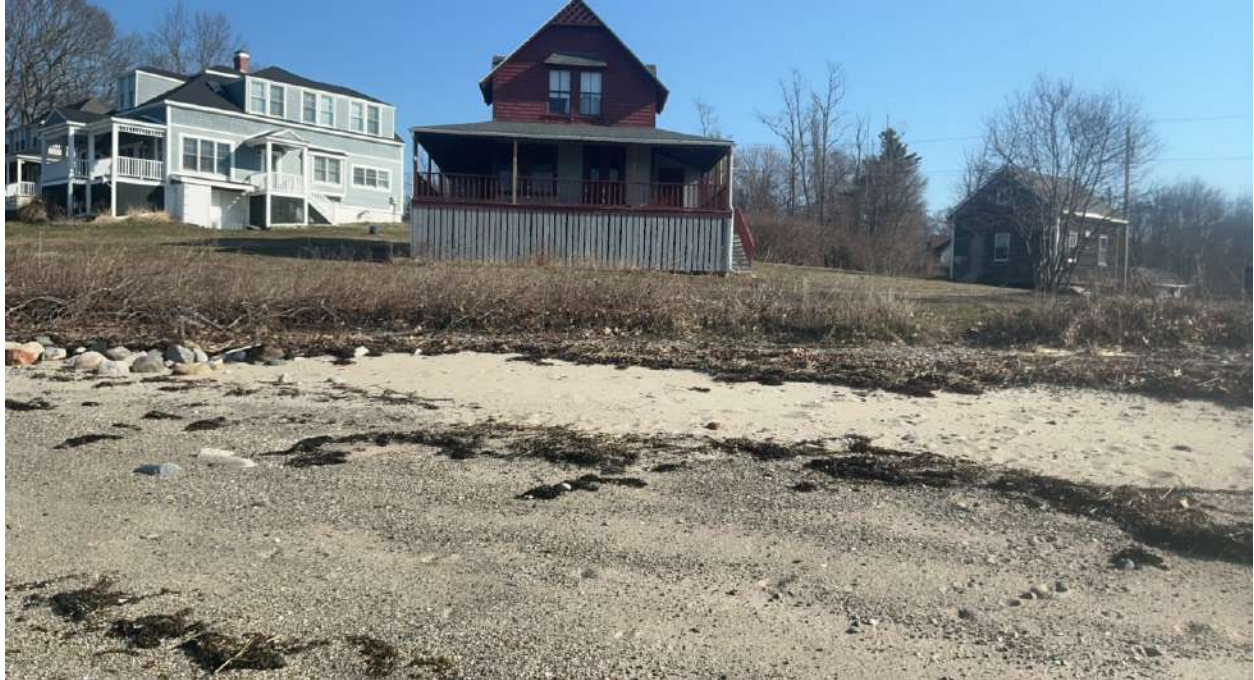
The property owners have observed long-term shoreline change and erosion exacerbated by severe winter storms in 2024. Historical photos from the early 1900s show a salt marsh extending along the shoreline of the property which is no longer present. Sea level rise is also impacting the property; the seaward point of the historical tax parcel is now below the highest astronomical tide line.

Figure 1: Photo of the cottage and shoreline in 2026.
