OUR SHORE Coastal Erosion Assessments and Site Reports: Great Diamond Island

Emma Polhemus, Shore Corps Steward, Maine Conservation Corps & Island Institute
May 2026

**OURSHORE Quick Assessment: Barge Landing & Property X
Great Diamond Island, ME**

OURSHORE Quick Assessment: Private Property A
Great Diamond Island, ME

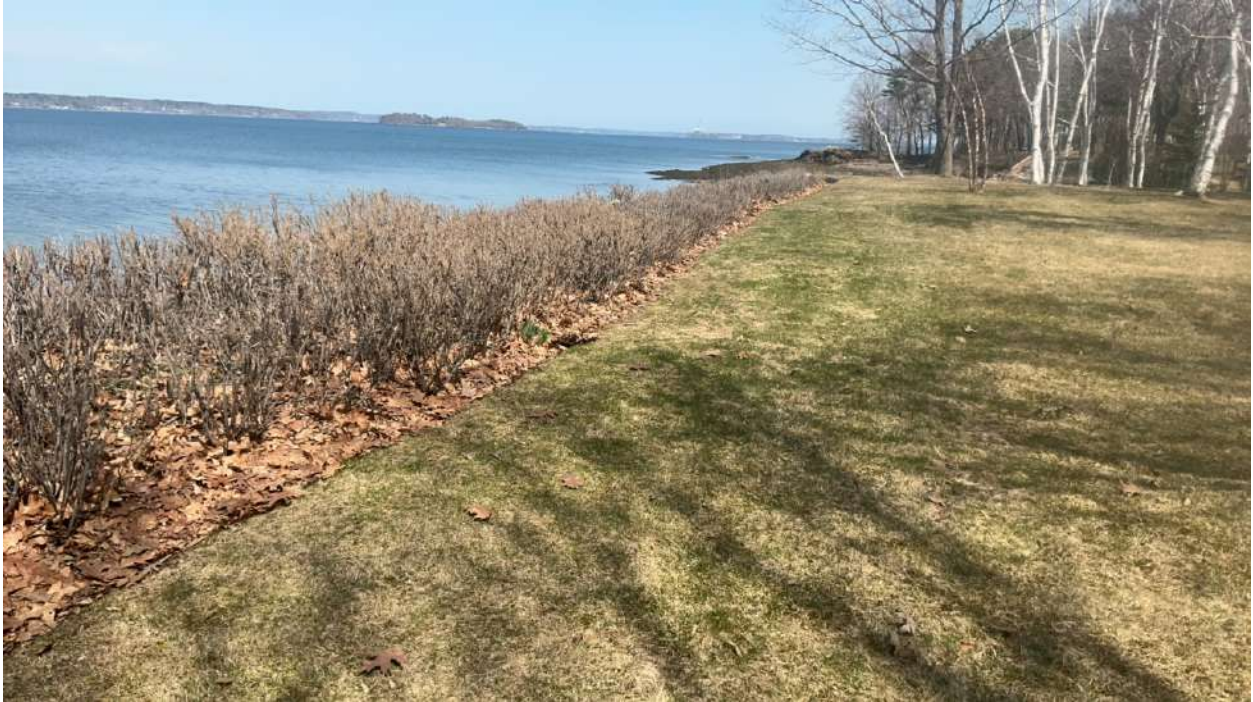
Figure 3: The private property inland of the bluff crest.

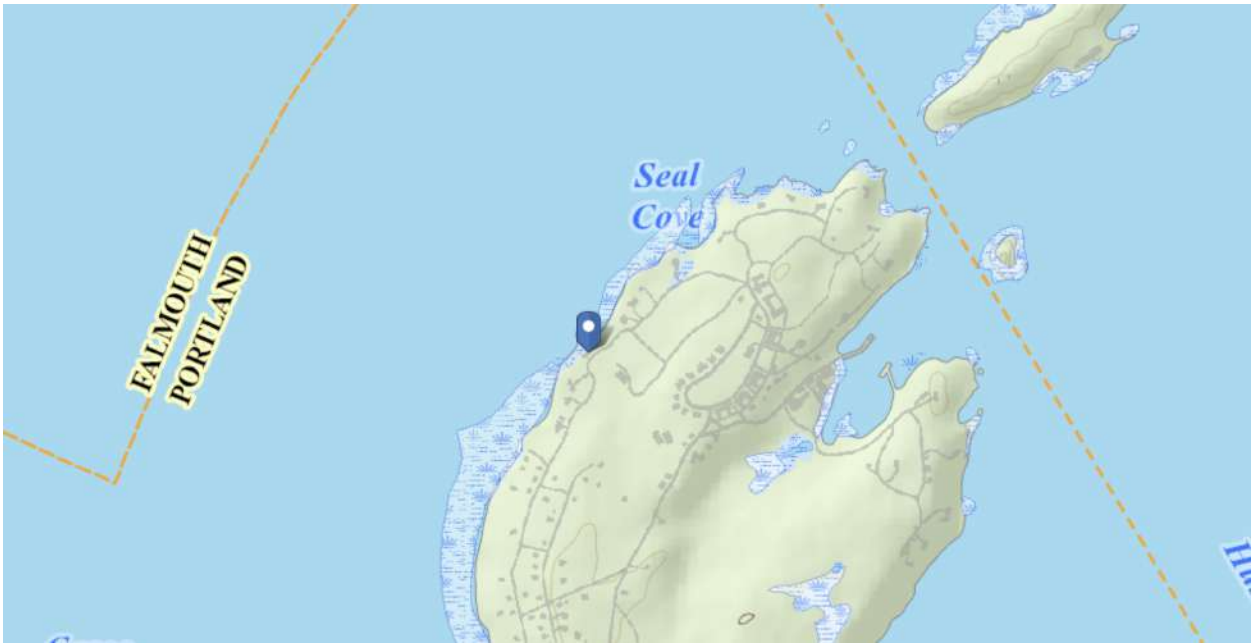
Figure 6: Beginning with Habitat map of the site showing National Wetland Inventory areas (white and blue pattern).

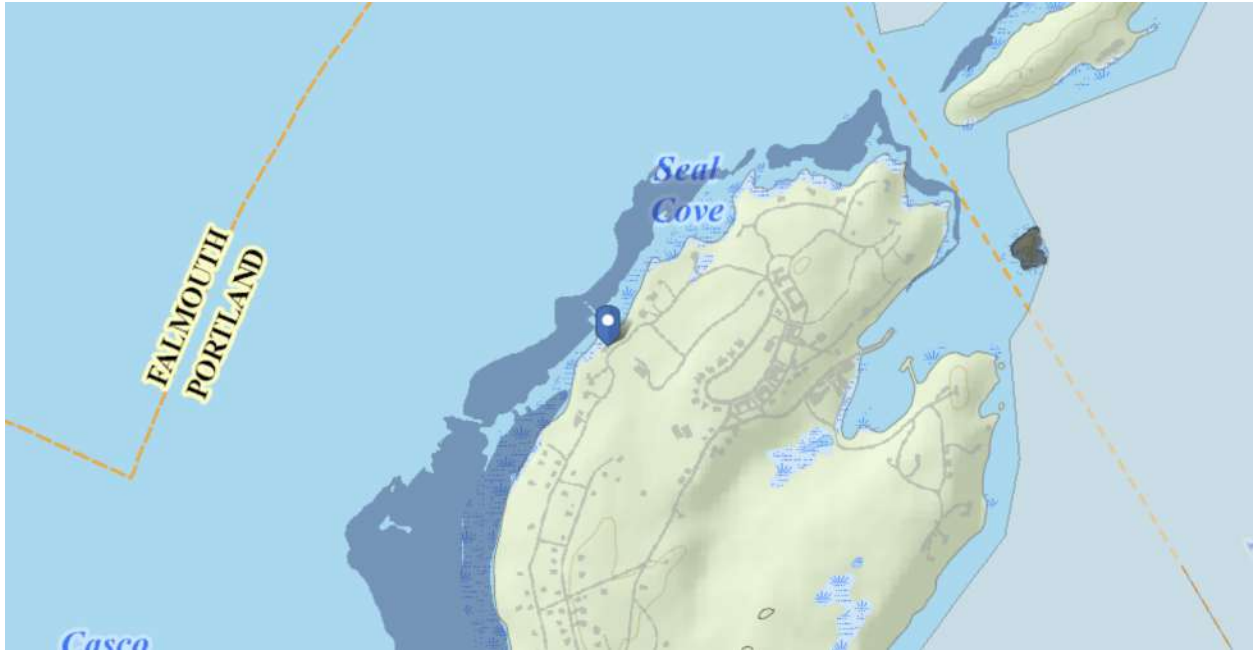
Figure 7: Beginning with Habitat map of the site showing high value Tidal Waterfowl and Wading Bird habitat (dark blue).

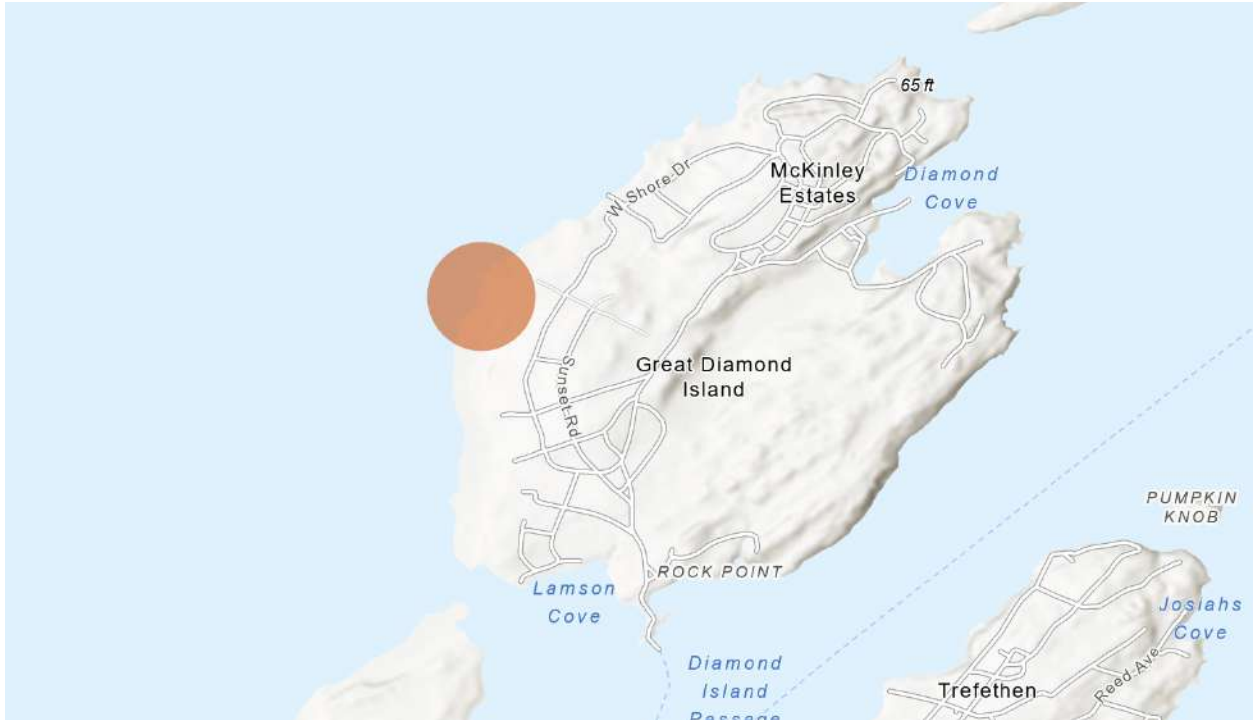
Figure 1: Map indicating the approximate location of the private property assessed.

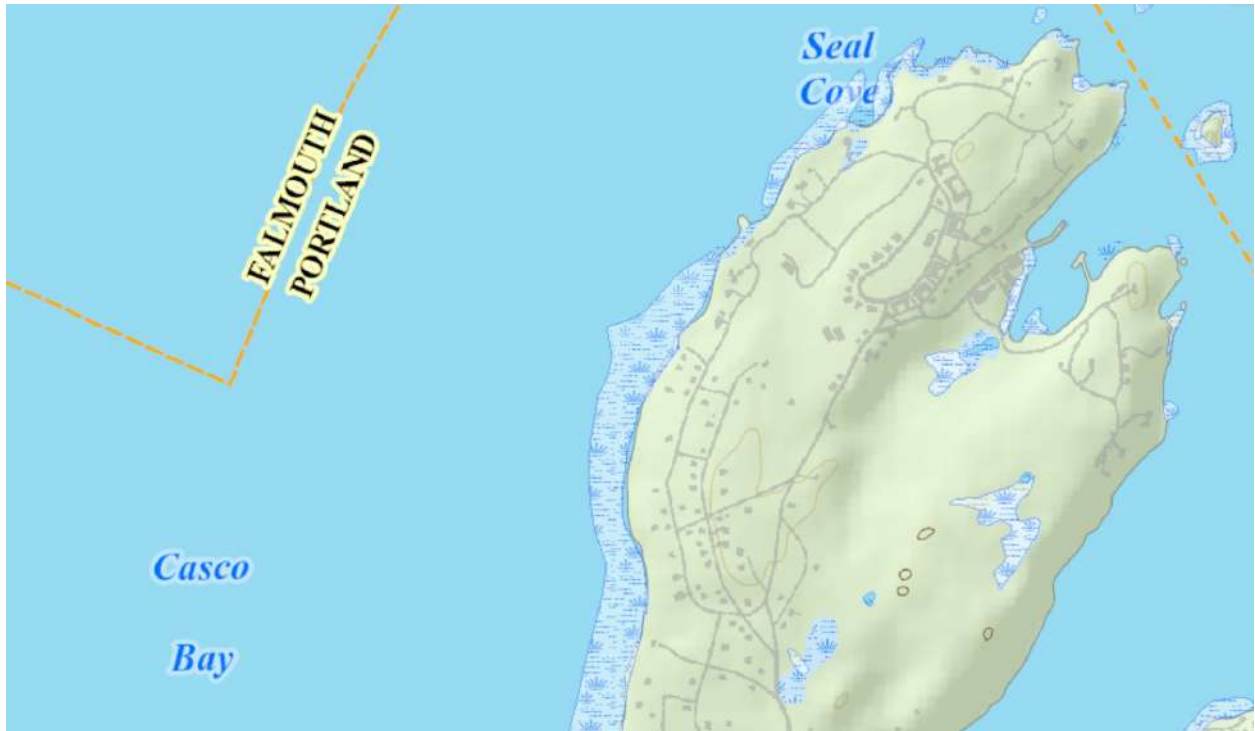
The intertidal zone in front of the property is mapped as a coastal wetland within the National Wetland Inventory (Fig. 5). The area is additionally mapped as high value Tidal Waterfowl and Wading Bird habitat (Fig. 6).

Figure 5: Beginning with Habitat Map of the site indicating National Wetland Inventory wetland locations (white and blue pattern).

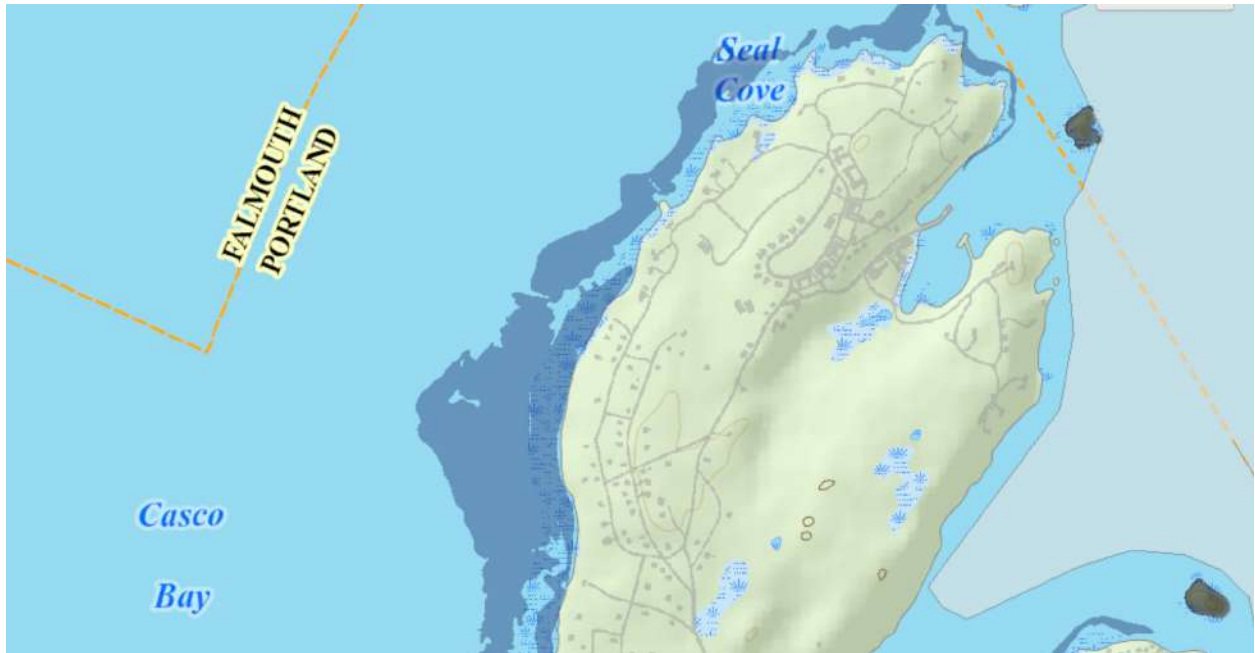
Figure 6: Beginning with Habitat map of the site indicating nearby high value Tidal Waterfowl and Wading Bird habitat areas (dark blue).

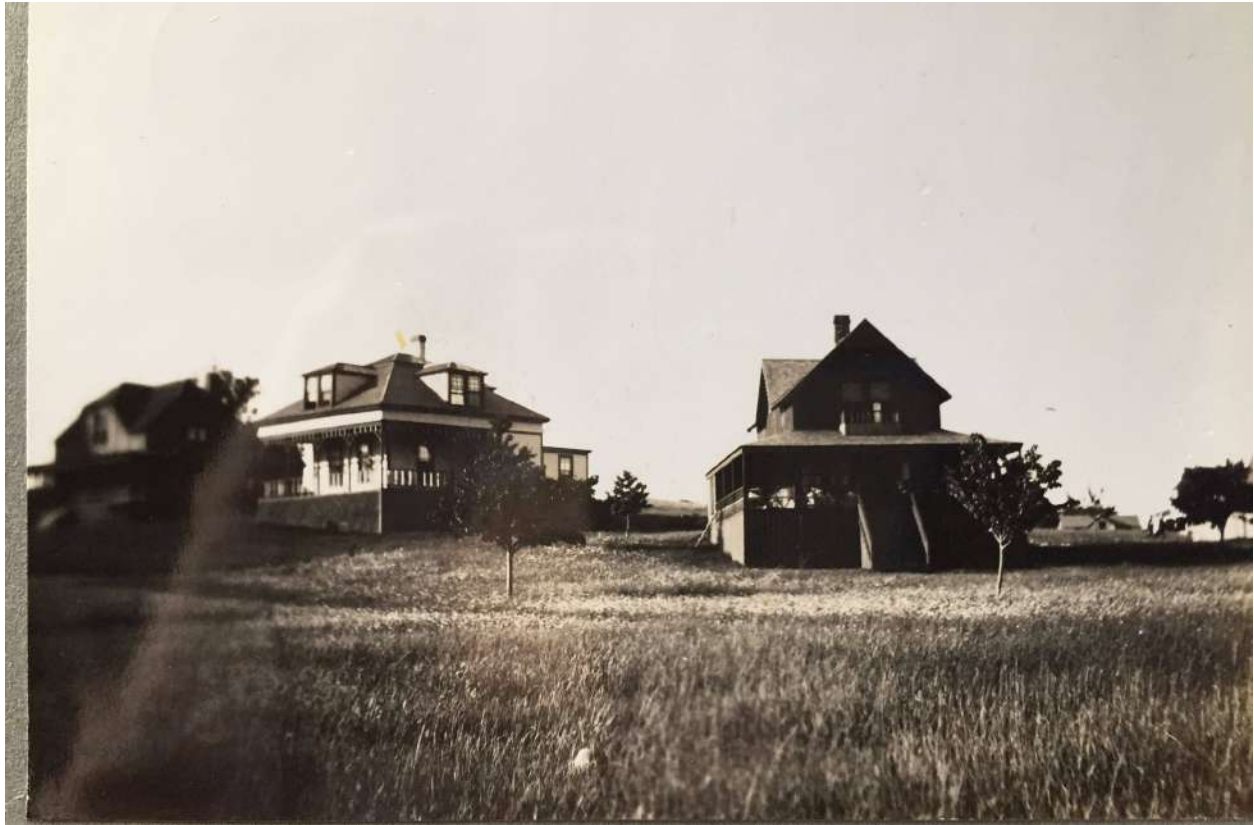
Figure 2: Historical photo of the cottage and shoreline taken in the early 1900s. Photo by Paul R. Stevens, provided by the Stevens family.

Salt marsh vegetation helps dissipate wave energy and buffer shorelines from erosion. The presence of salt marsh in historical photos suggests that this site may be a good candidate for marsh restoration as a nature-based erosion control strategy. Some marsh restoration sites benefit from the addition of a protective sill, which is usually constructed from logs anchored into the intertidal zone parallel to the shoreline (Fig. 8). A sill helps to reduce the energy of waves reaching the area of marsh restoration as well as allowing for adjustments to the elevation of the marsh to create suitable growing conditions for plantings. The Home Place Team has installed several successful examples of this technique along the coast of Maine; more information can be found in their presentation at the 2025 OUR SHORE conference.¹ Due to the location of the site near the Lamson Cove sandbar, transportation and infrastructure would have to be considered in the siting of a sill structure in the intertidal.

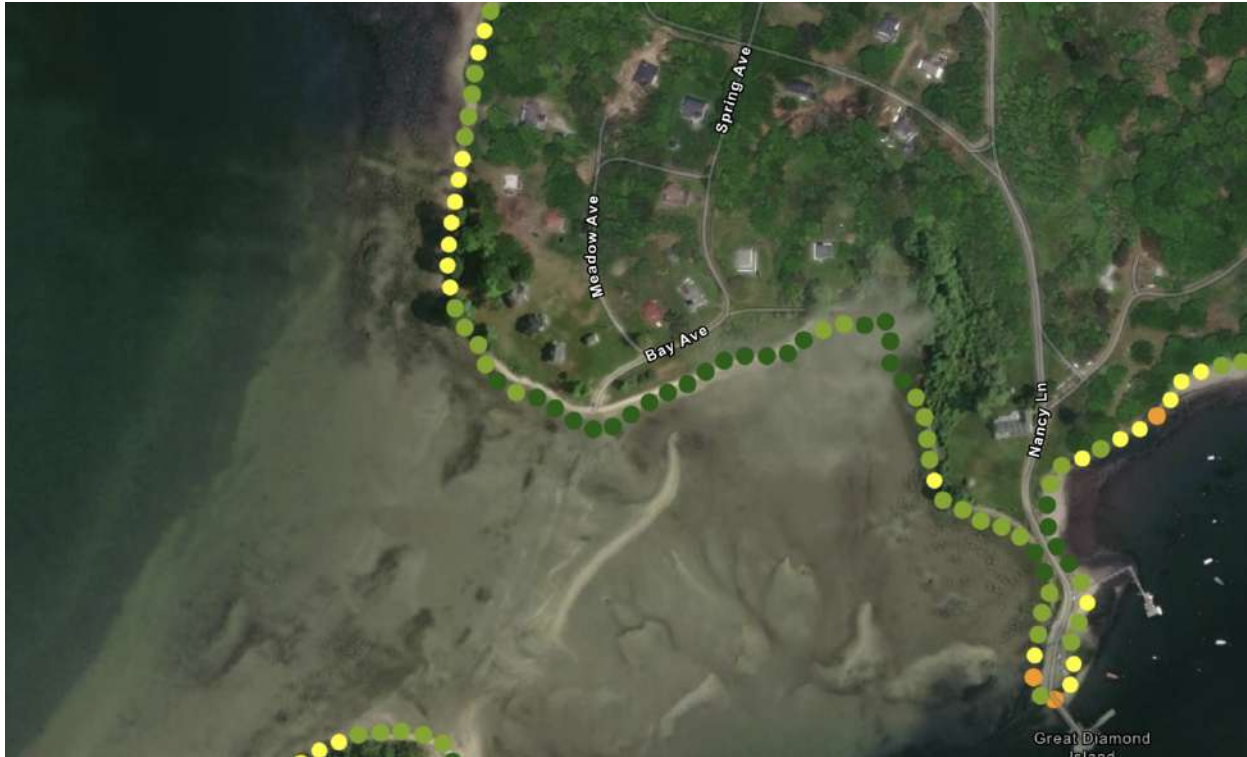
Maine Geological Survey's Living Shoreline Decision Support Tool ranks the site as Highly Suitable for living shoreline approaches (Fig. 6). Environmental factors like the shallow intertidal zone, low bank height, and low annualized fetch provide beneficial conditions to establish plantings in combination with bioengineering approaches.

Figure 6: Maine Geological Survey Living Shoreline Decision Support Tool showing the Lamson Cove area. Dark green circles indicate that a site is ranked Highly Suitable for a living shoreline.

Because the toe of the bank has eroded, a biodegradable stabilization material such as coconut coir logs are recommended to provide additional support while plantings establish. The coir log should be placed directly along the eroding edge of the bank and staked in place (Fig. 7). Vegetation is added for long-term stability and slope protection. Vegetation can be seeded or planted directly into the coir log, or into the soil behind the log.

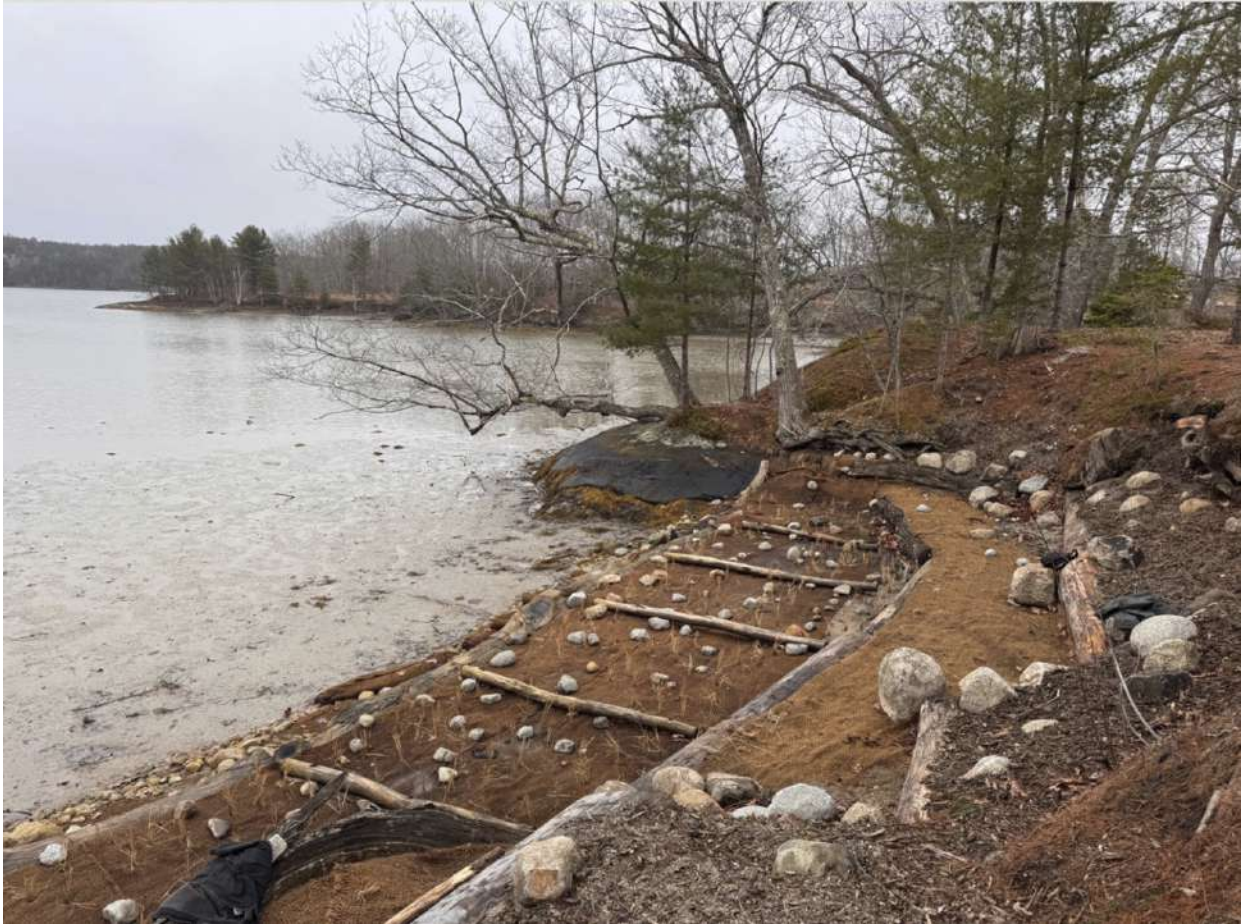
Figure 8: Example of a log sill installed for marsh restoration. (Photo from Treyball & Bernacki, 2025).
